TECHNICAL INSPECTION REPORT

OPERATION CROSSROADS. U.S.S. INDEPENDENCE (CVL 22)

TEST ABLE.

VOLUME 2 OF 4 [10]

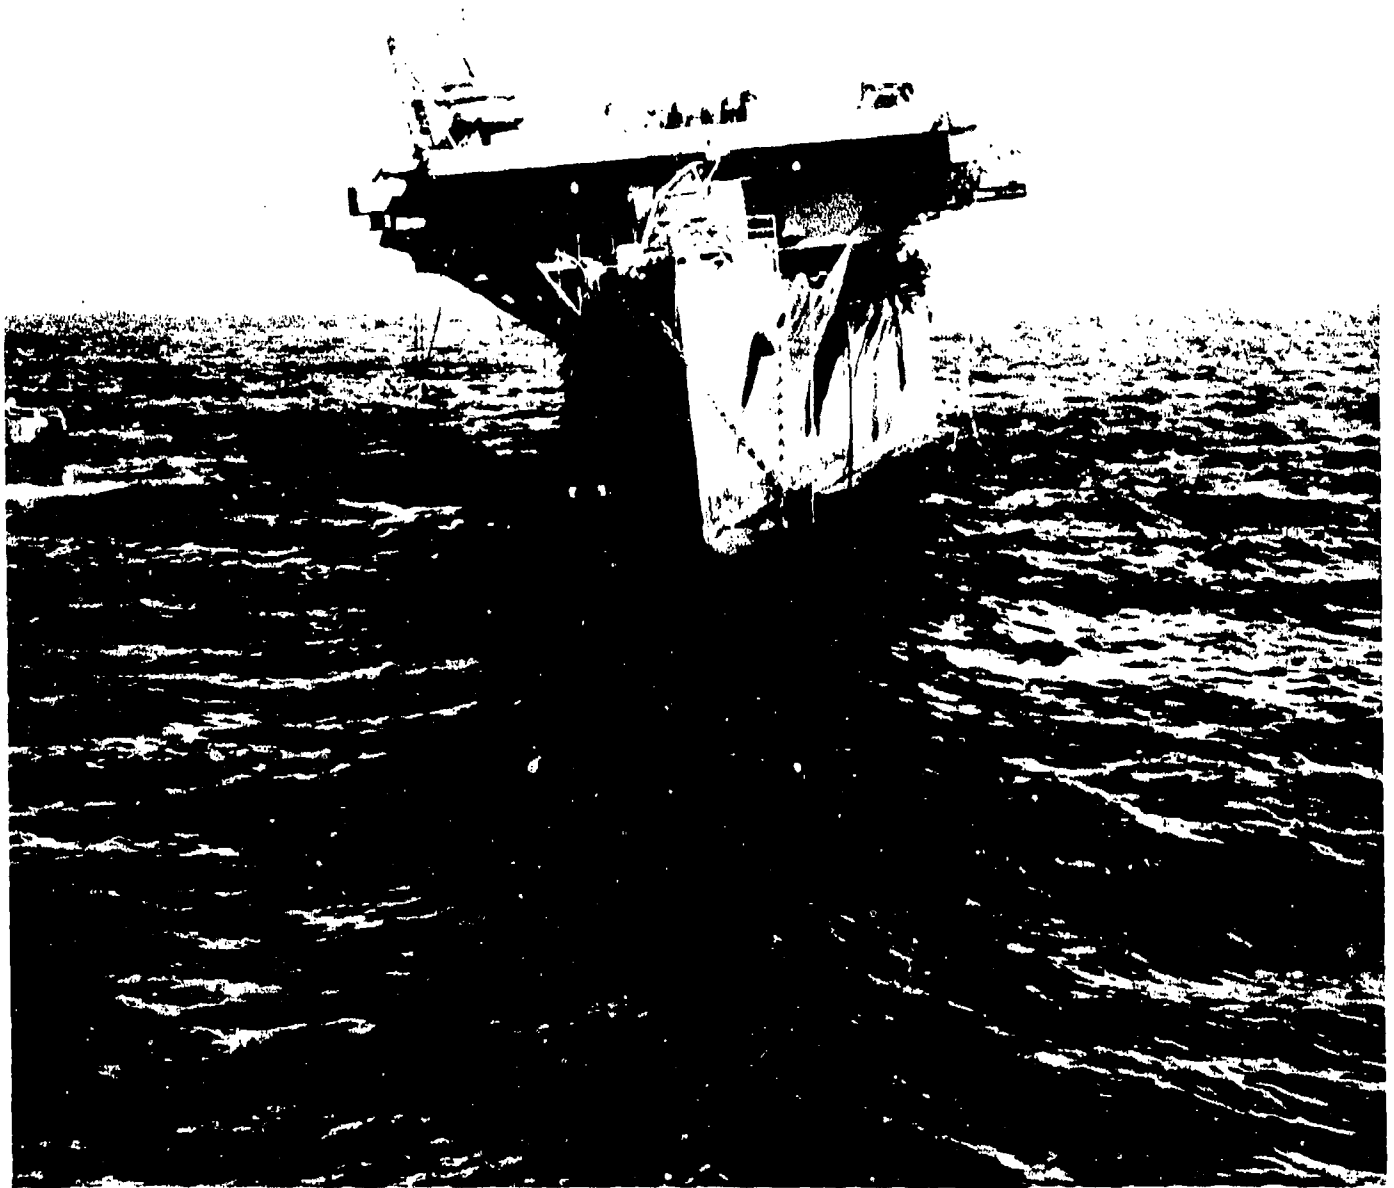
AA-CR-227-87-4. View of bow after Test A.

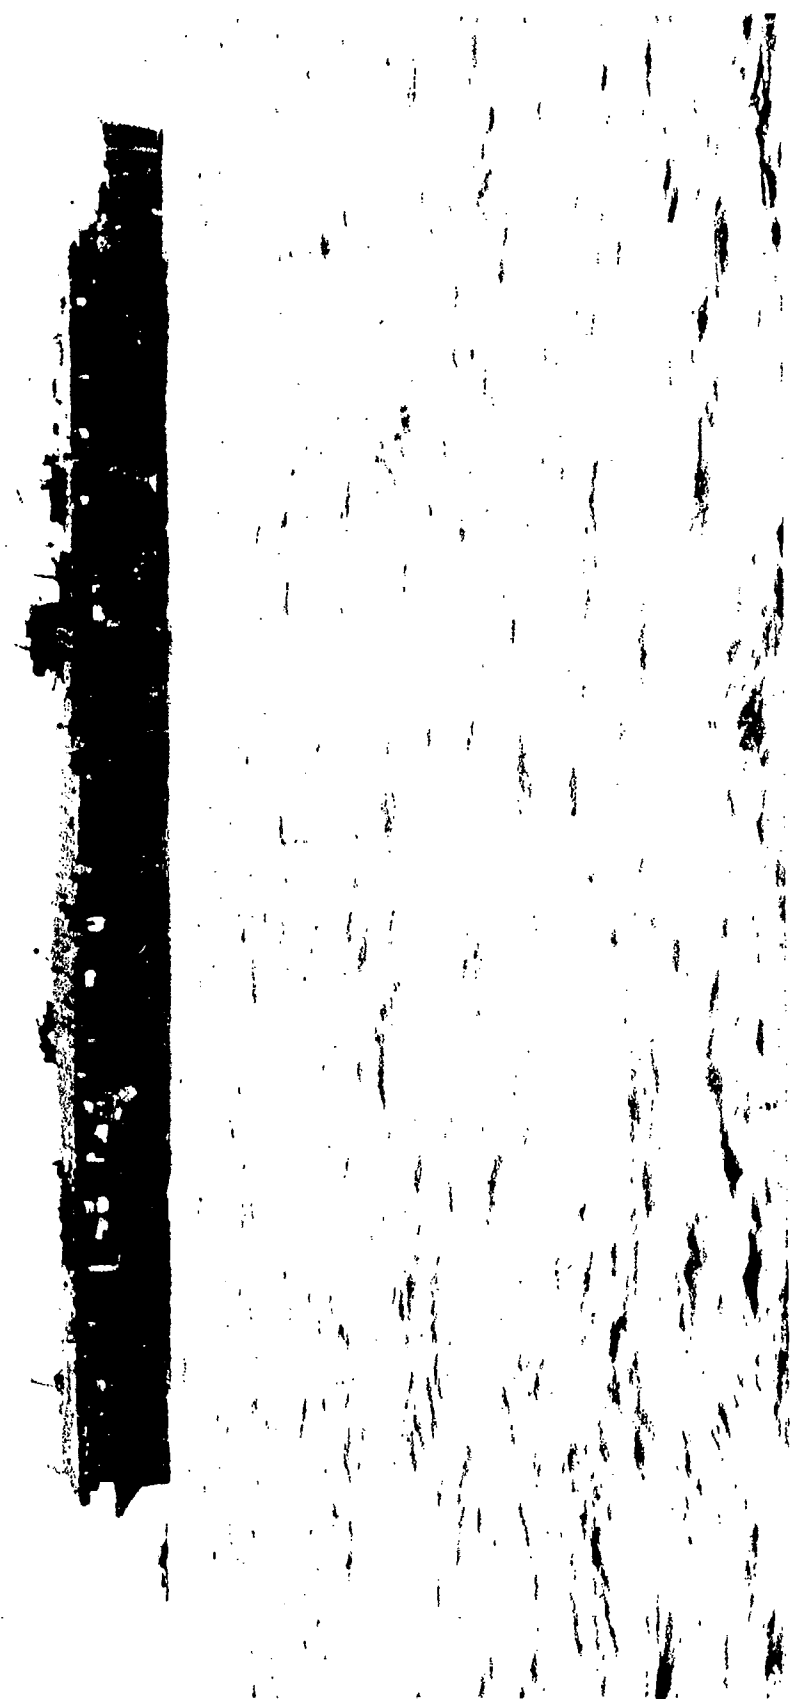
AA-CR-227-87-6. Broadside view-starboard-after Test A.

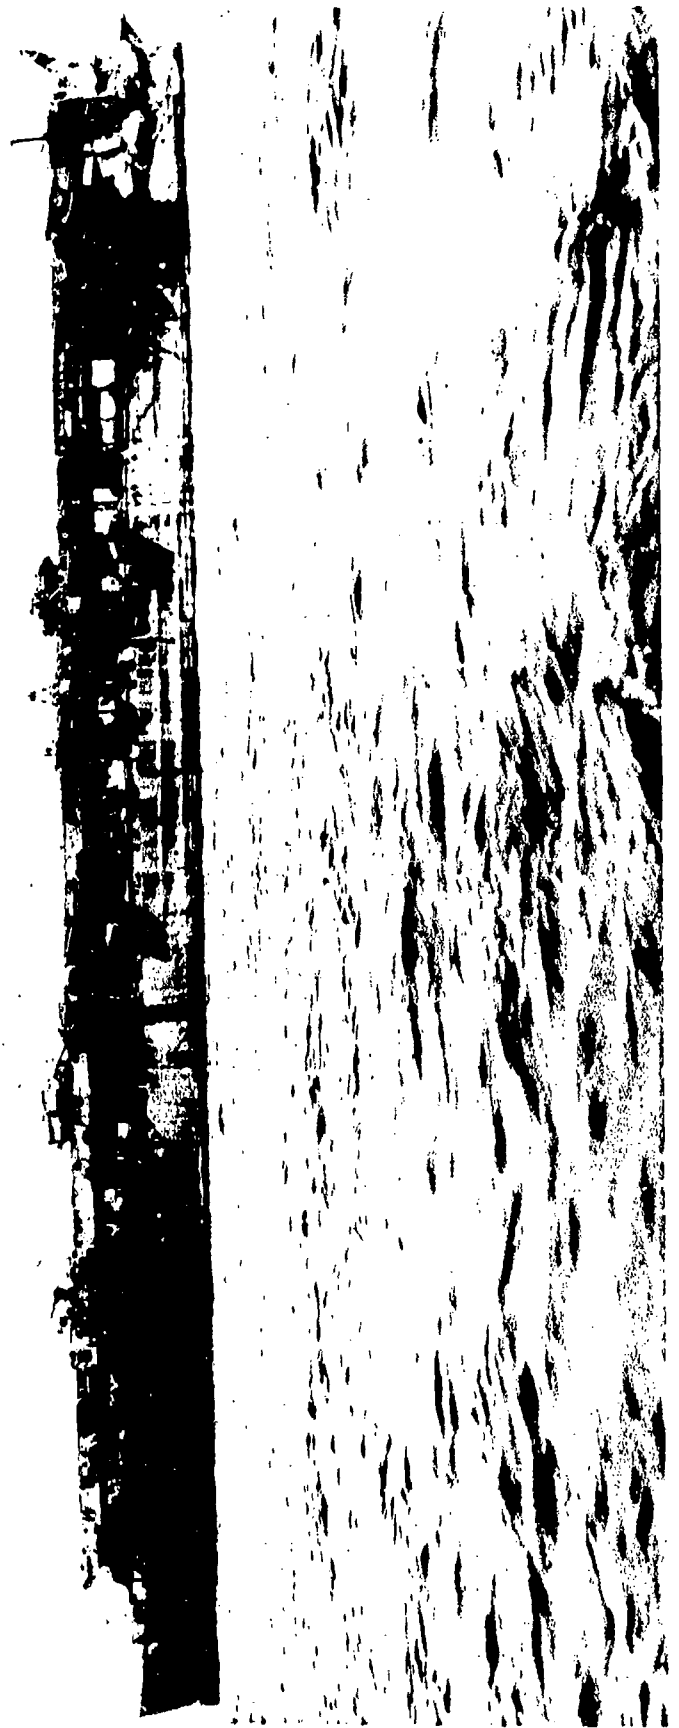
AA-CR-227-92-97. Broadside view-port-after Test A.

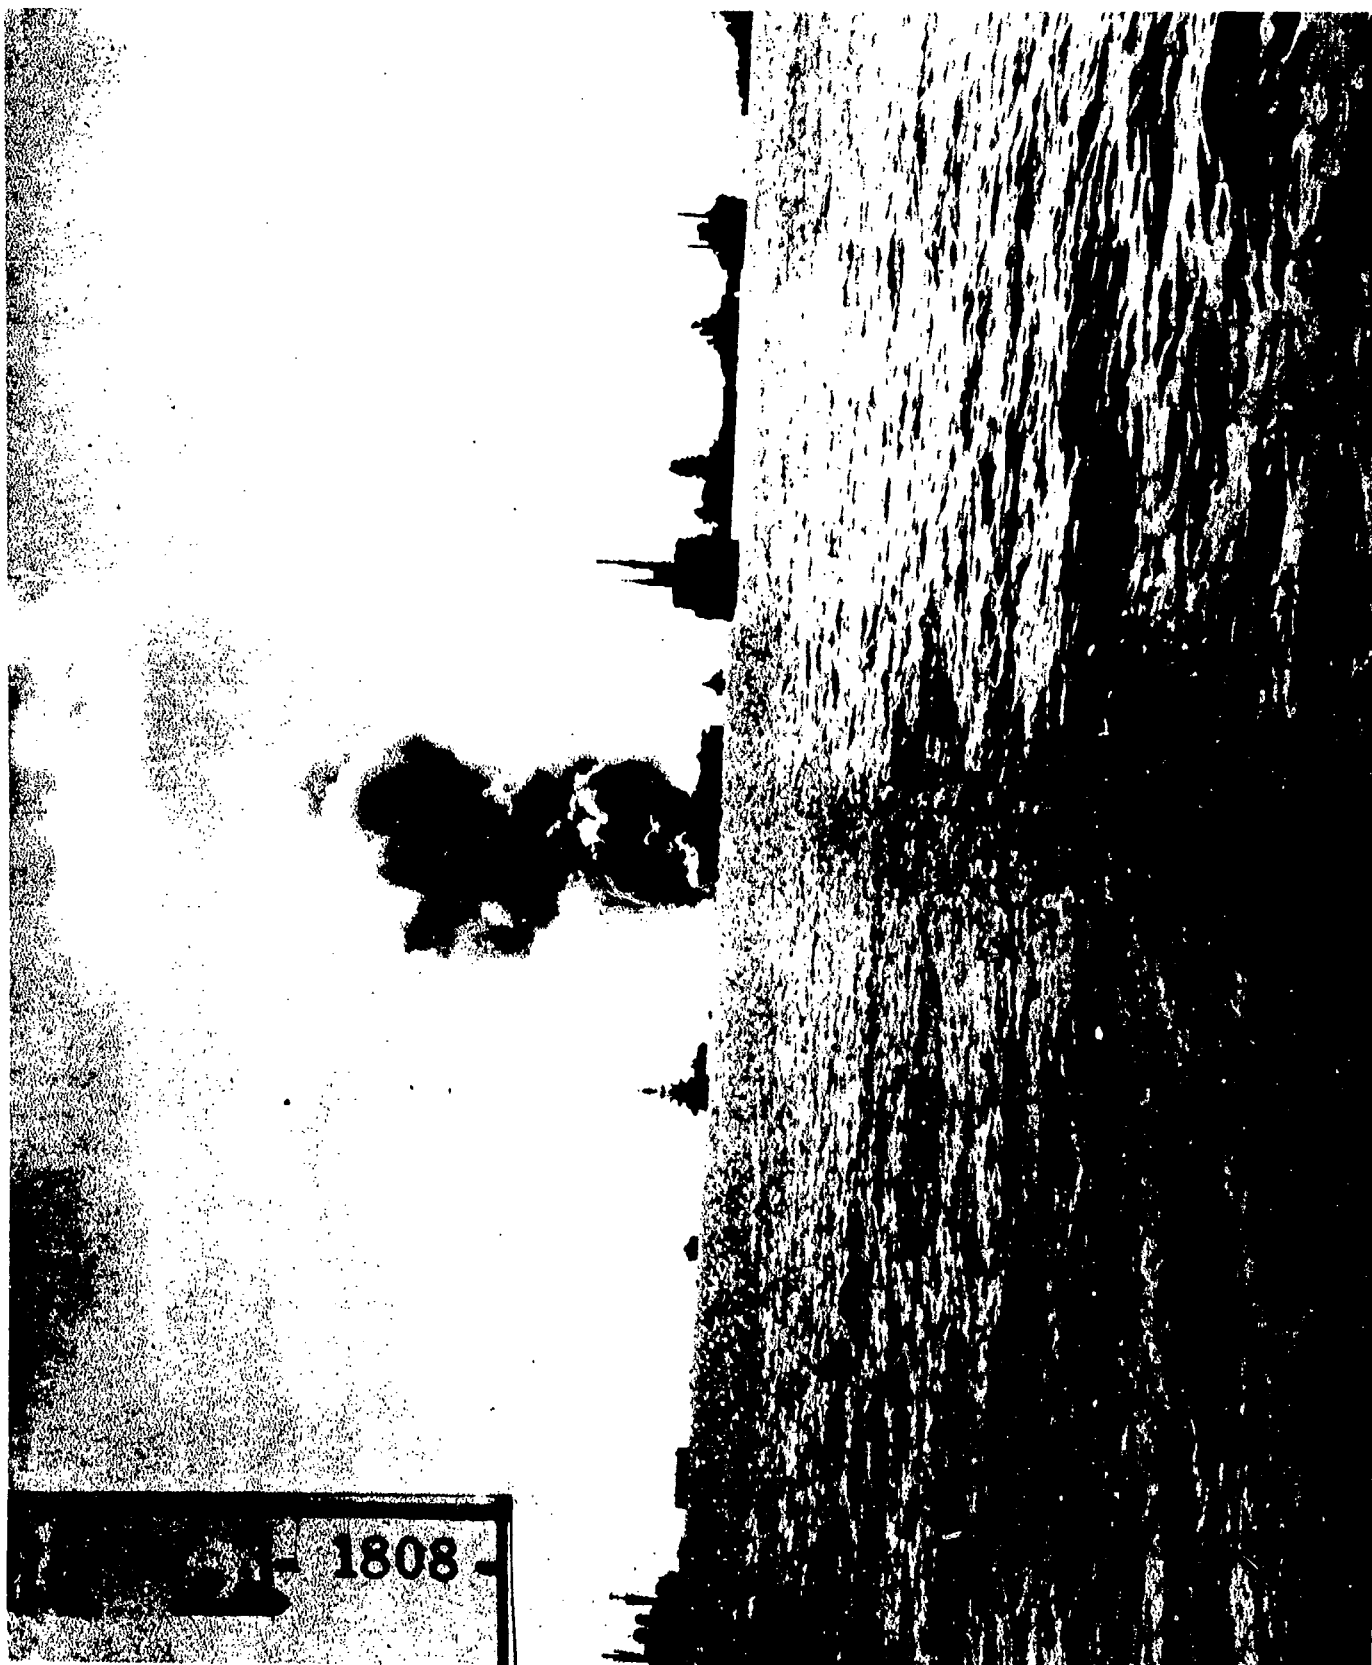
AA-CR-62-1808-6. Flare-up on stern of INDEPENDENCE, probably due to low order detonation in torpedo stowage, viewed from starboard at H-hour plus 5 2/3.

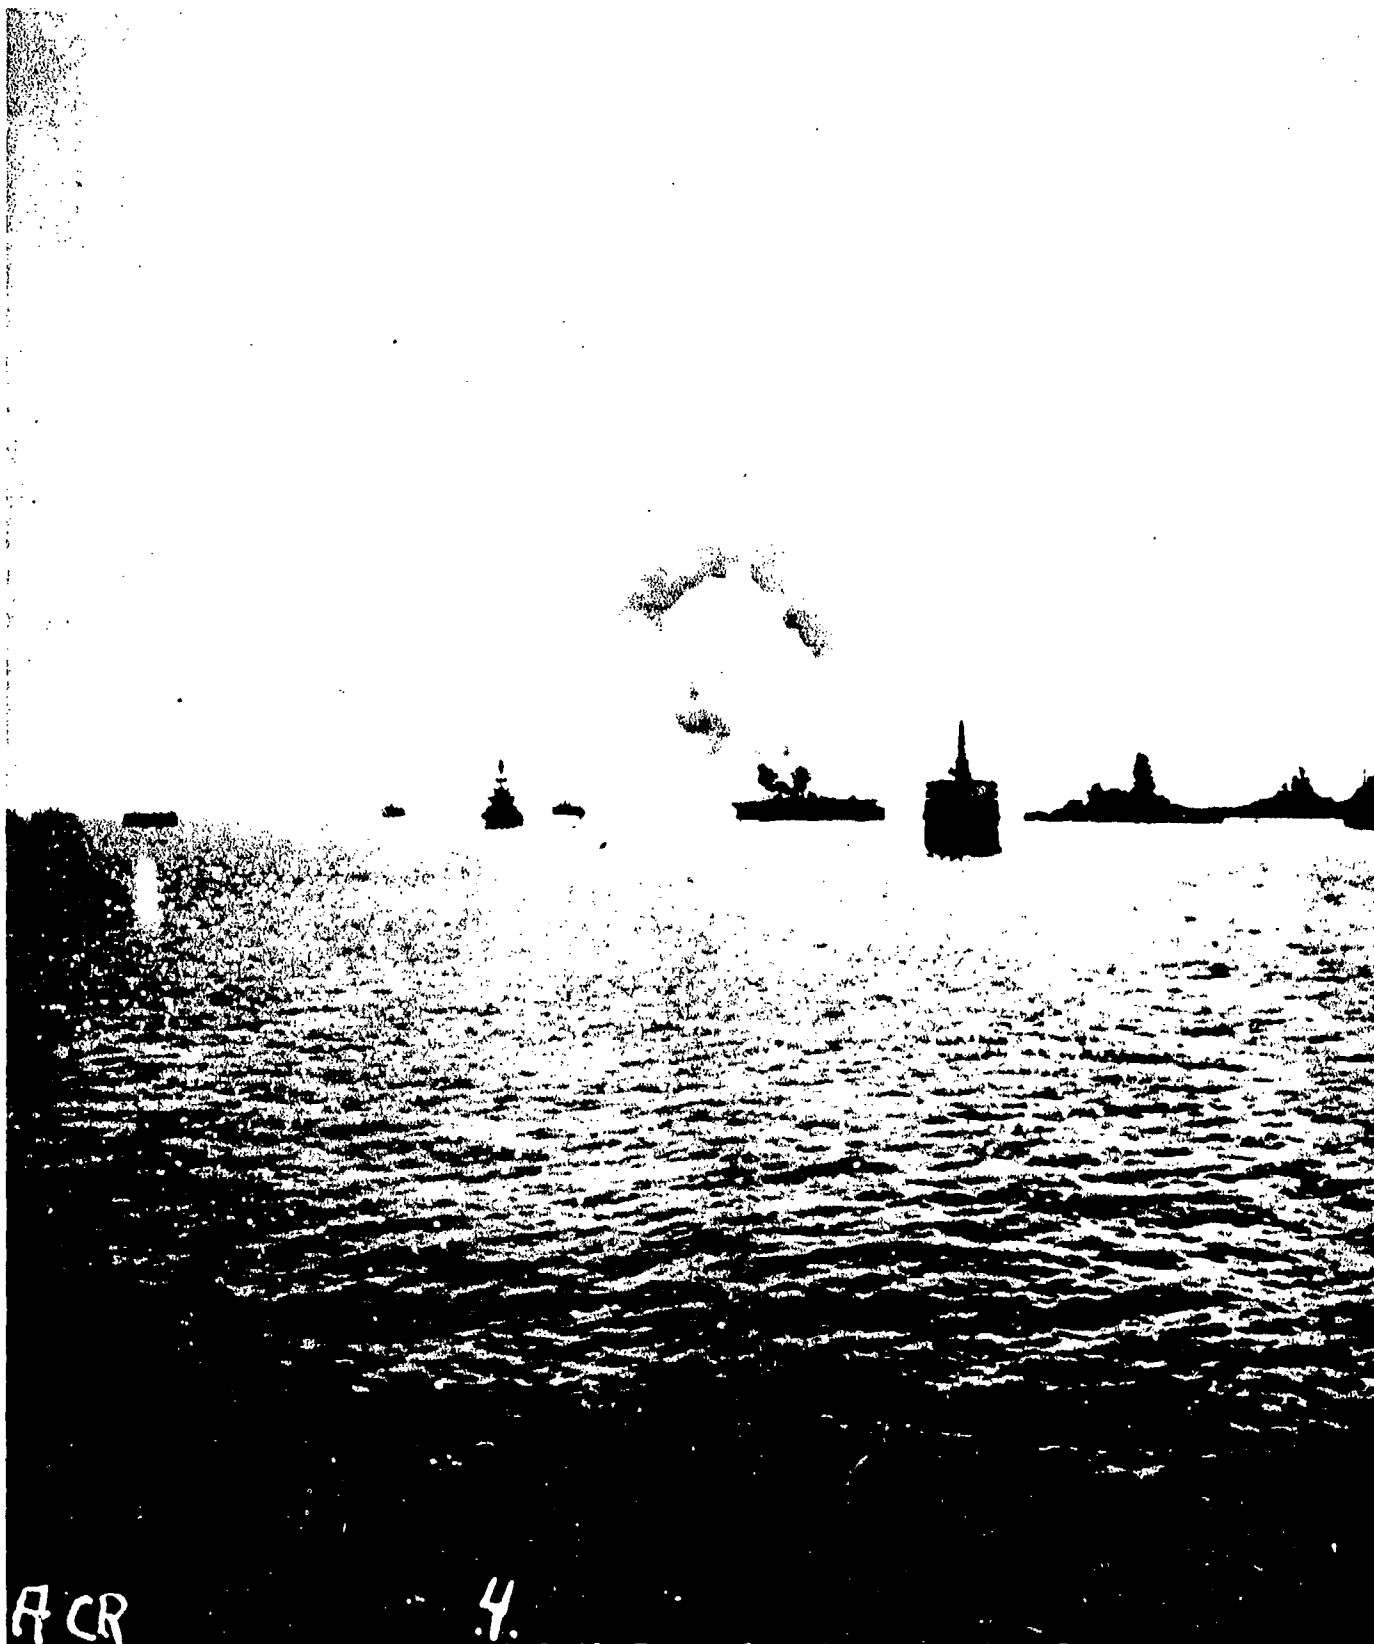
AA-CR-80-1893-4. Flare-up on stern of INDEPENDENCE, probably due to low order detonation in torpedo stowage, viewed from starboard a few minutes after 1808-6.

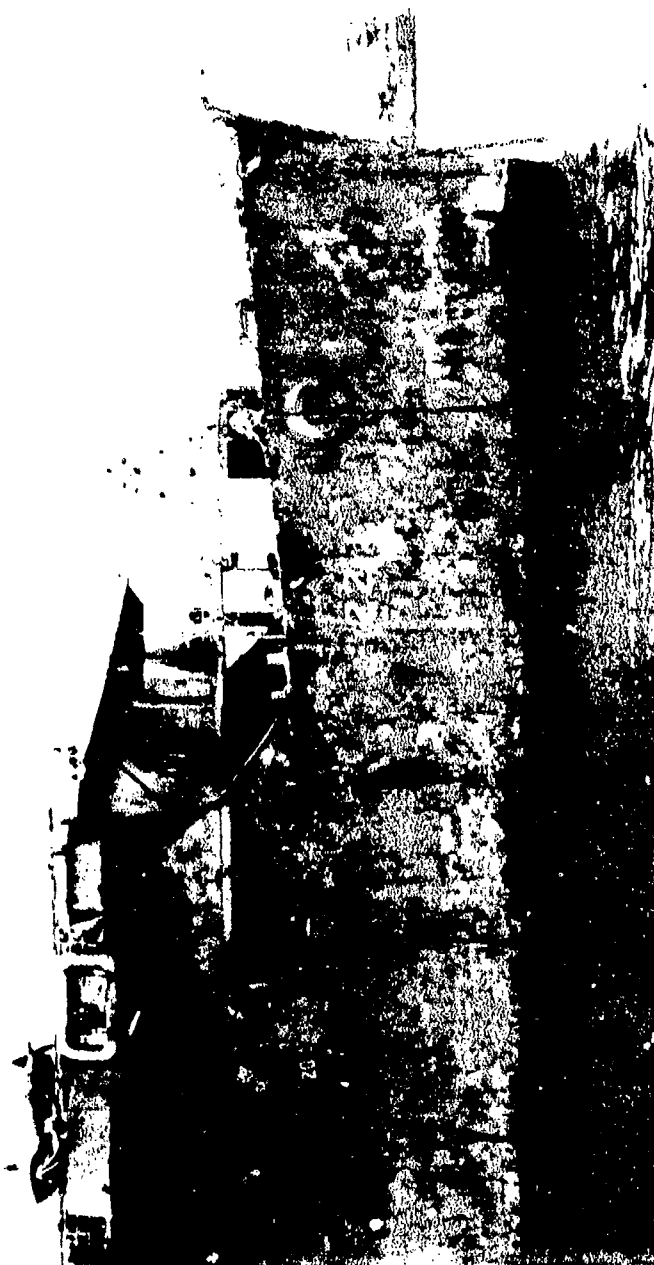
ABCR 79-4067

AB-CR-79-4067-1. After Baker. Starboard bow view, bow to frame 25.

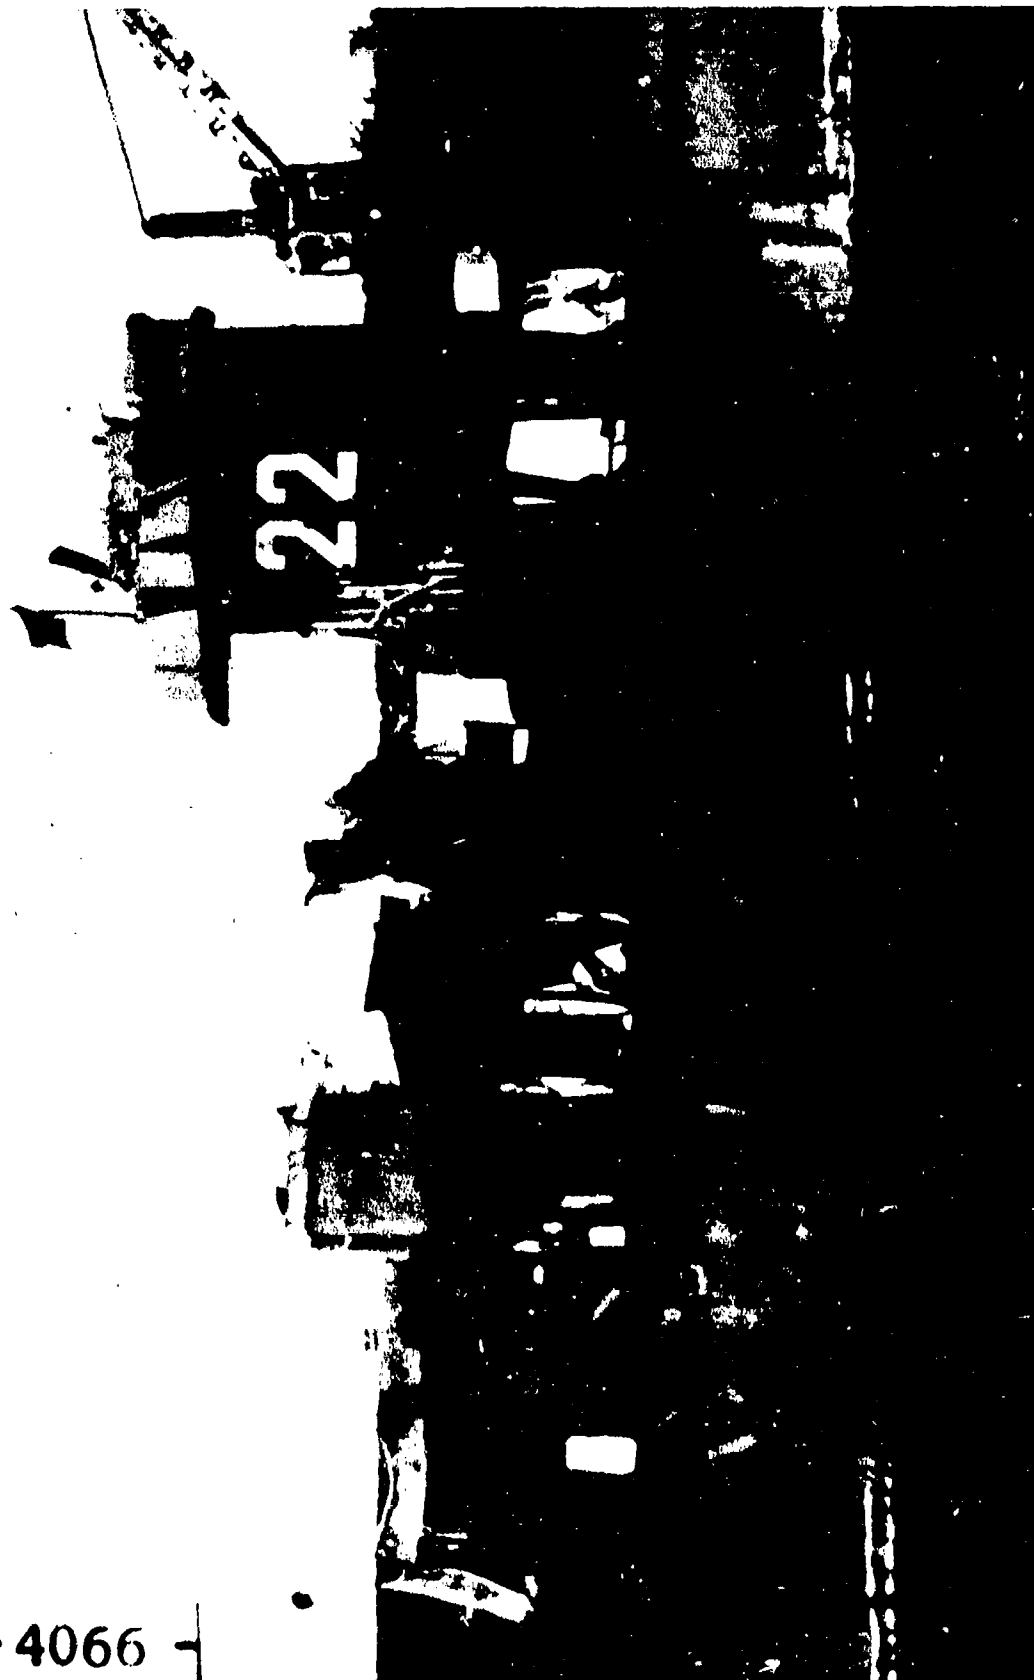
ABCR 79-4066 -

AB-CR-79-4066-3. After Baker. Starboard view, frames 40 to 54.

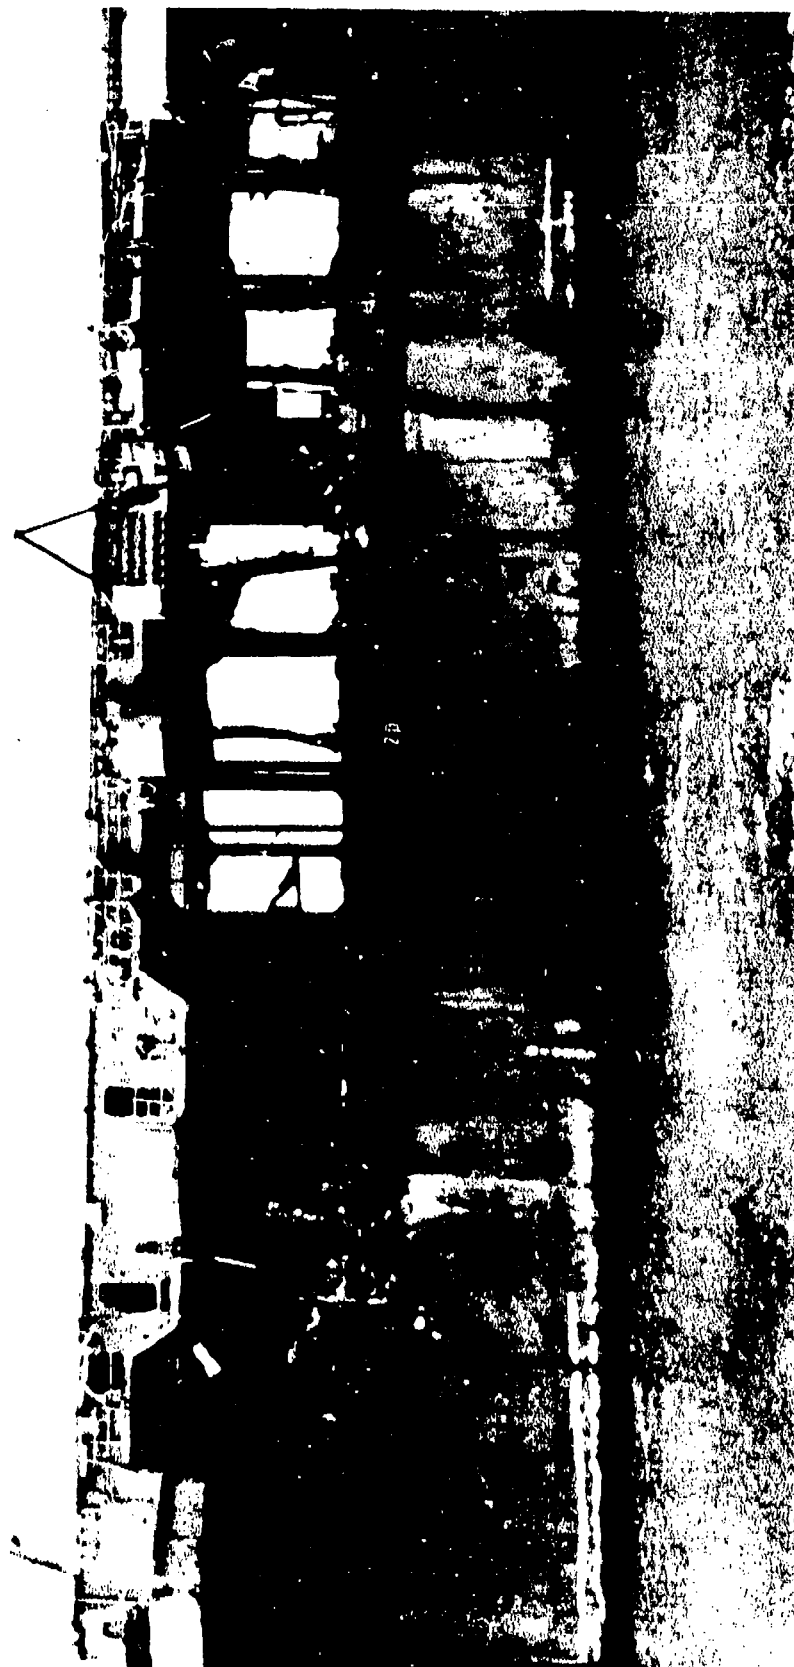
AB CR 79 4066 -

AB-CR-79-4066-5. After Baker. Starboard view, frames 100 to 139.

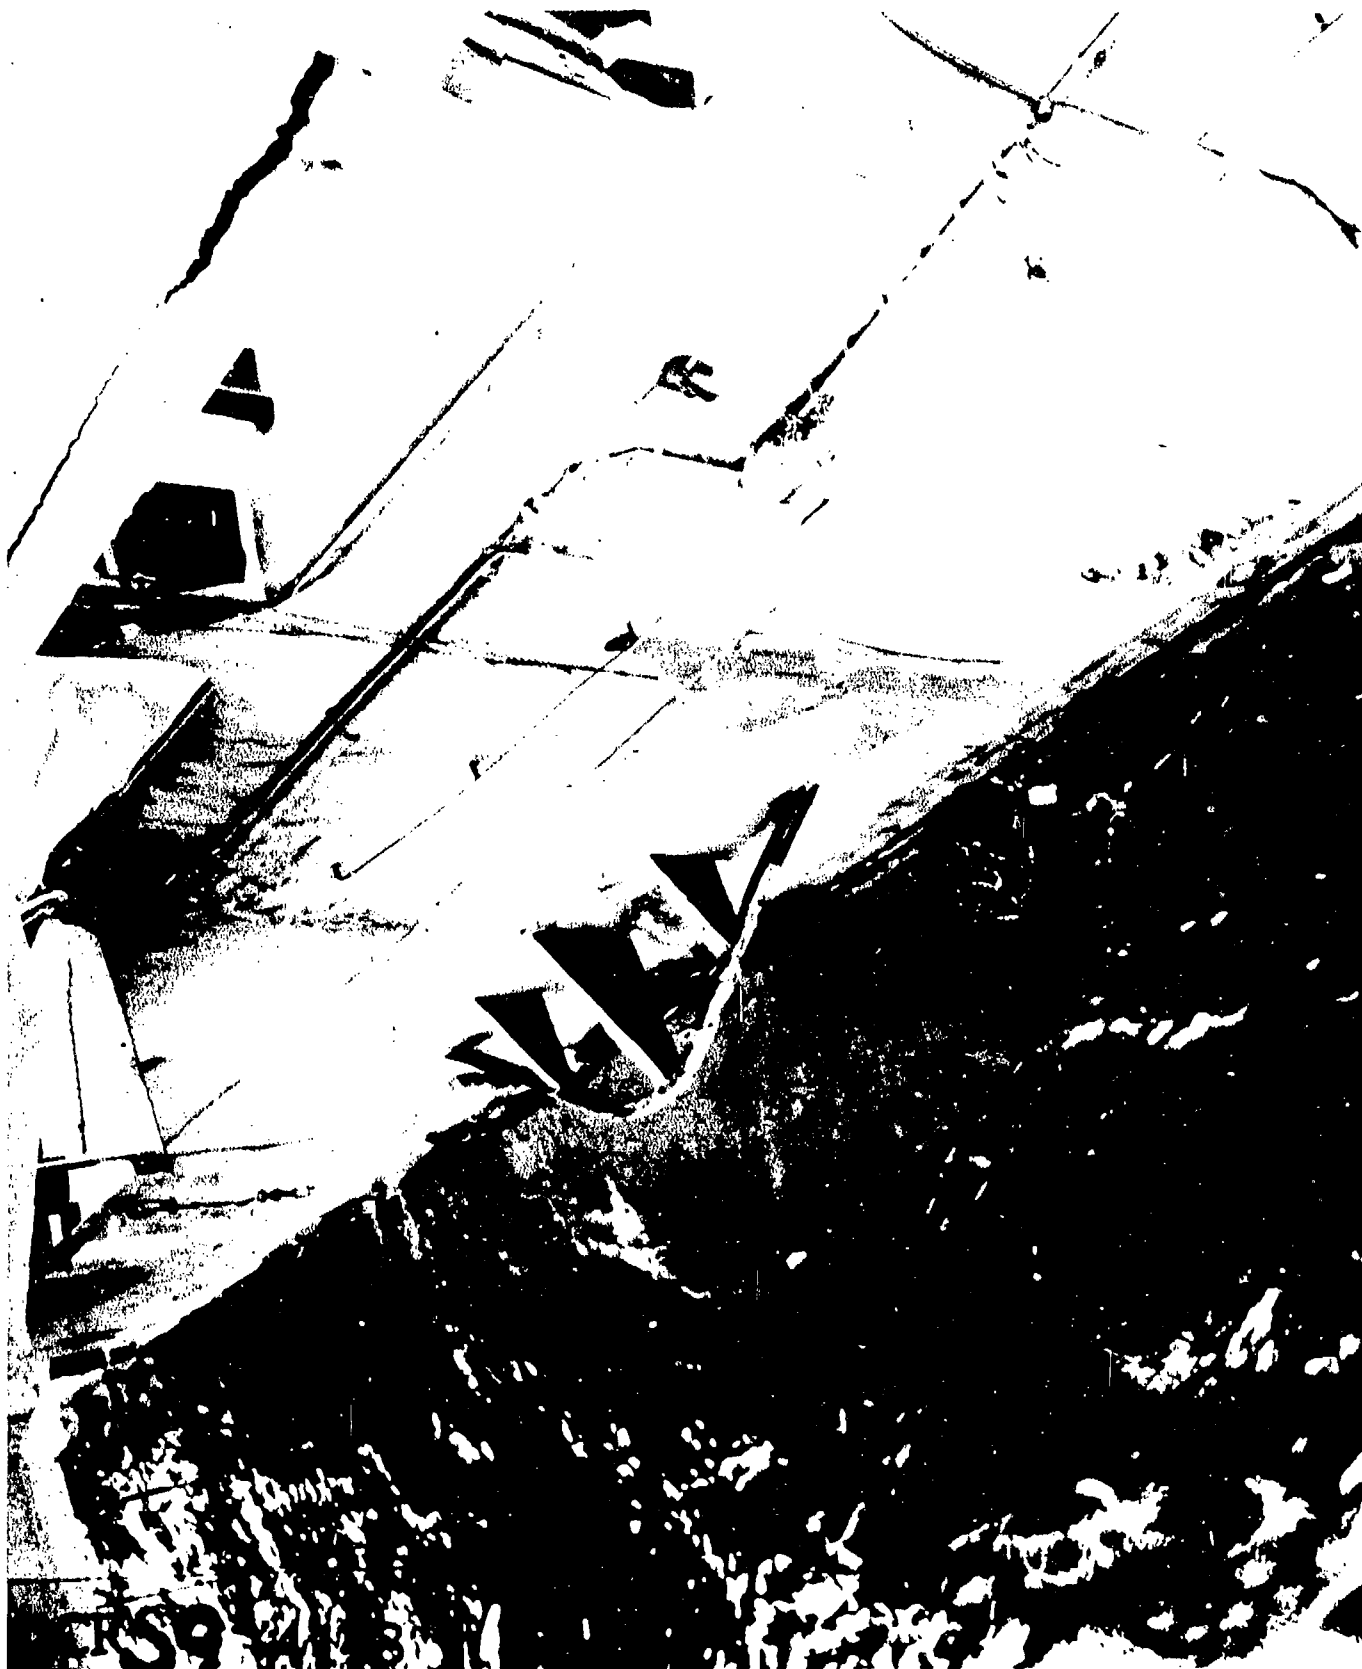
AA-CR-59-4148-1. General view of starboard shell, frames 115-133.
Shell wrinkle can be seen above propeller guard.

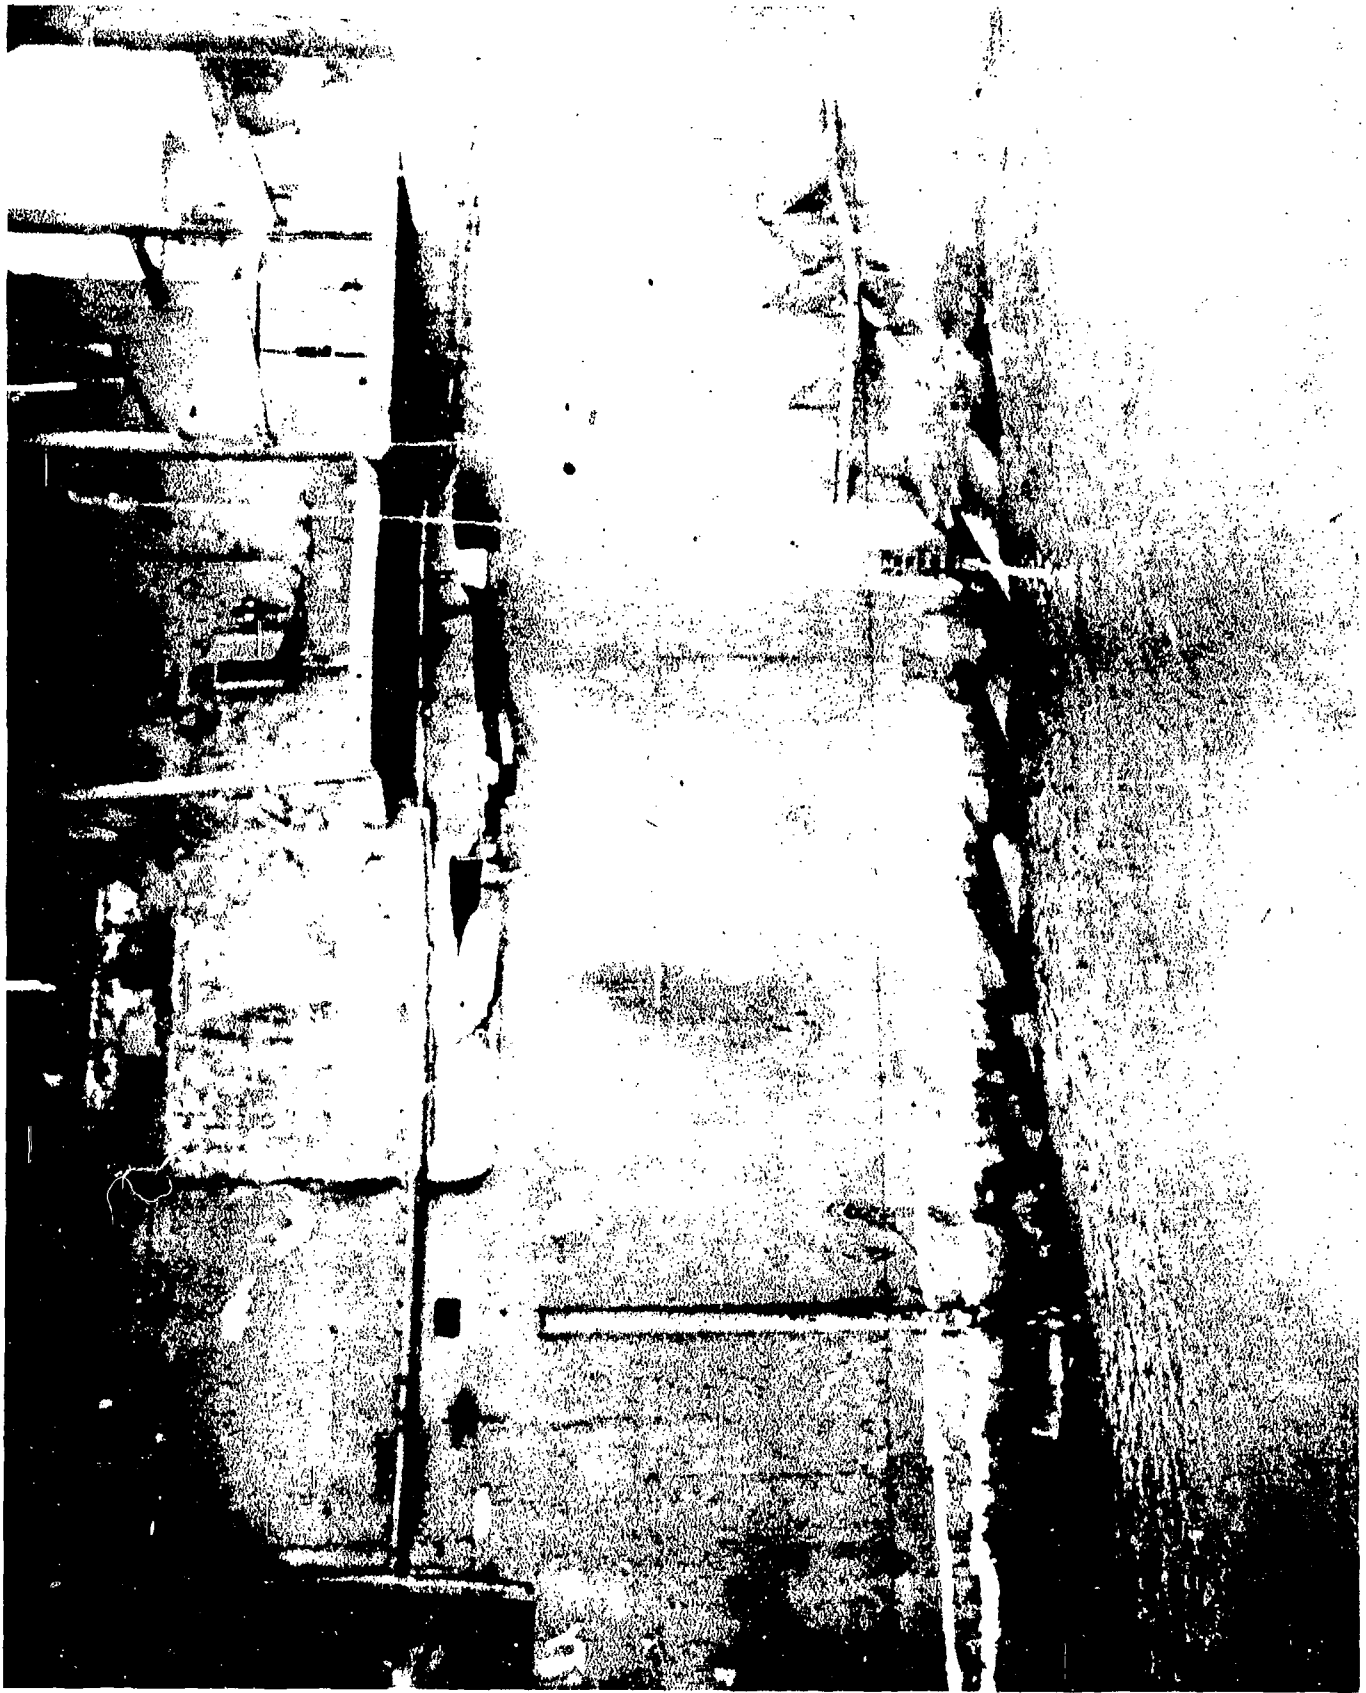
AA-CR-71-2073-2. Starboard shell, frames 120 to 137. Note wrinkles in shell below third deck at waterline.

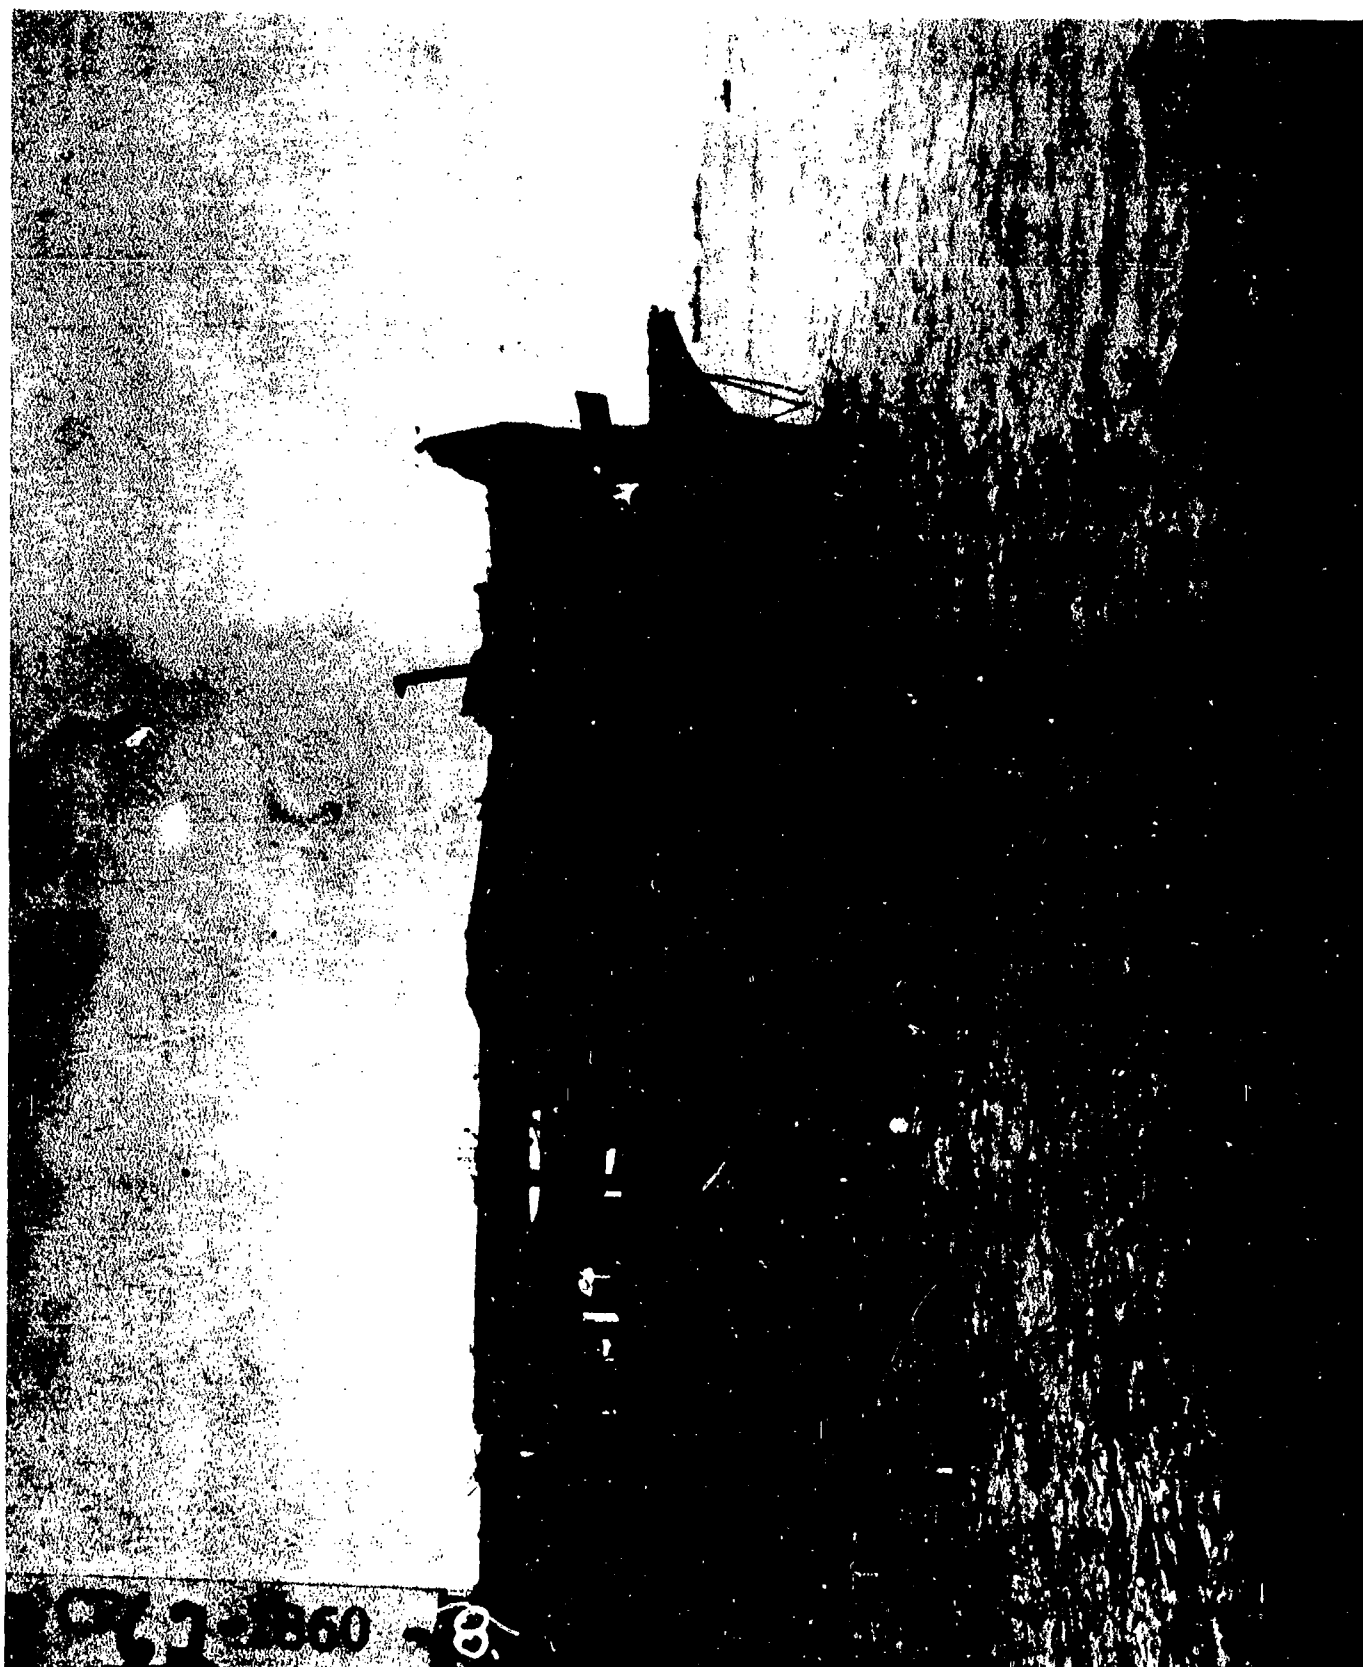
AA-CR-62-1860-8. After section viewed from off port quarter.

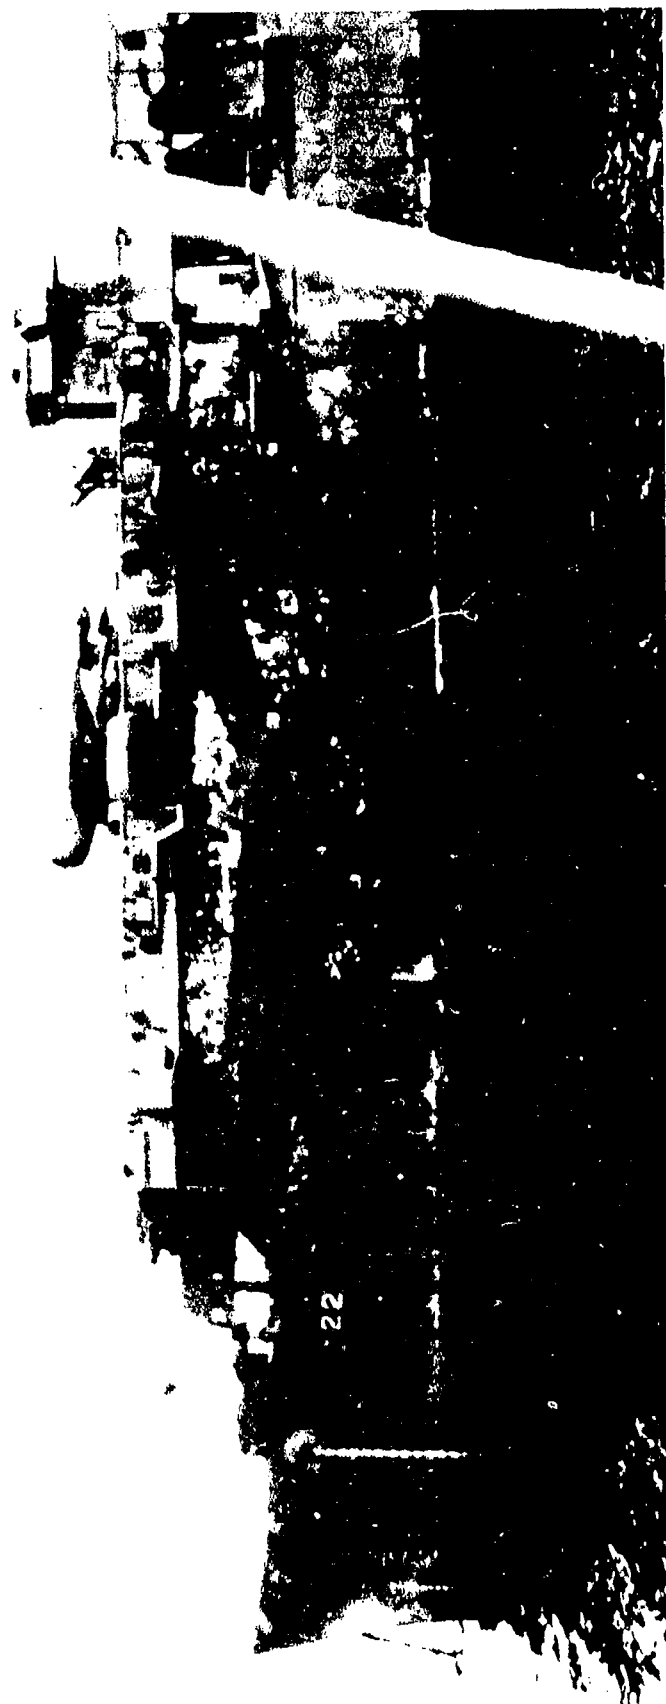
AB-CR-221-353-24. Forward port hull area, viewed from off port bow.

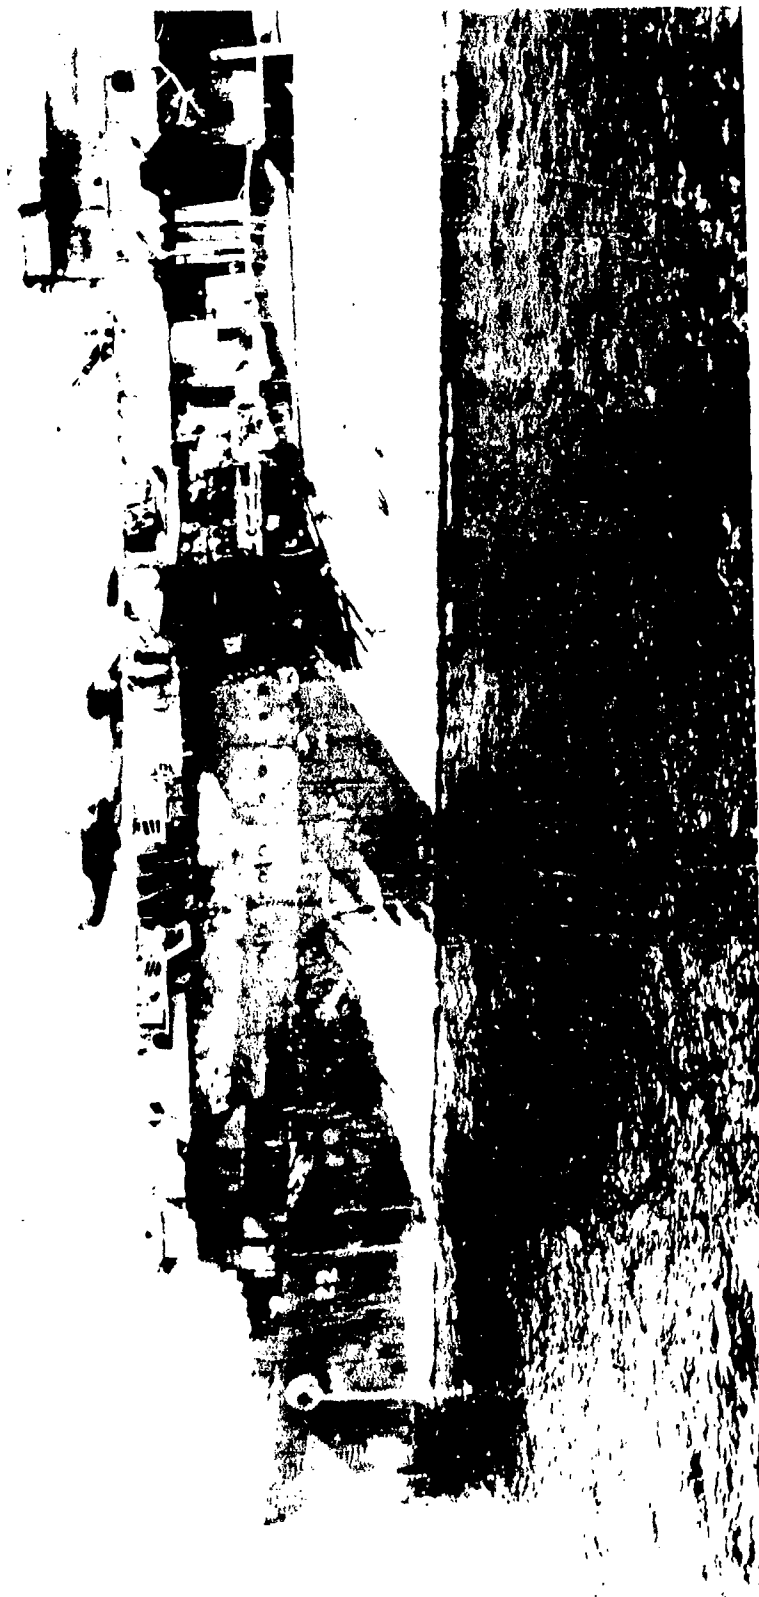
AB-CR-221-353-23. Forward port shell area, viewed from off port beam.

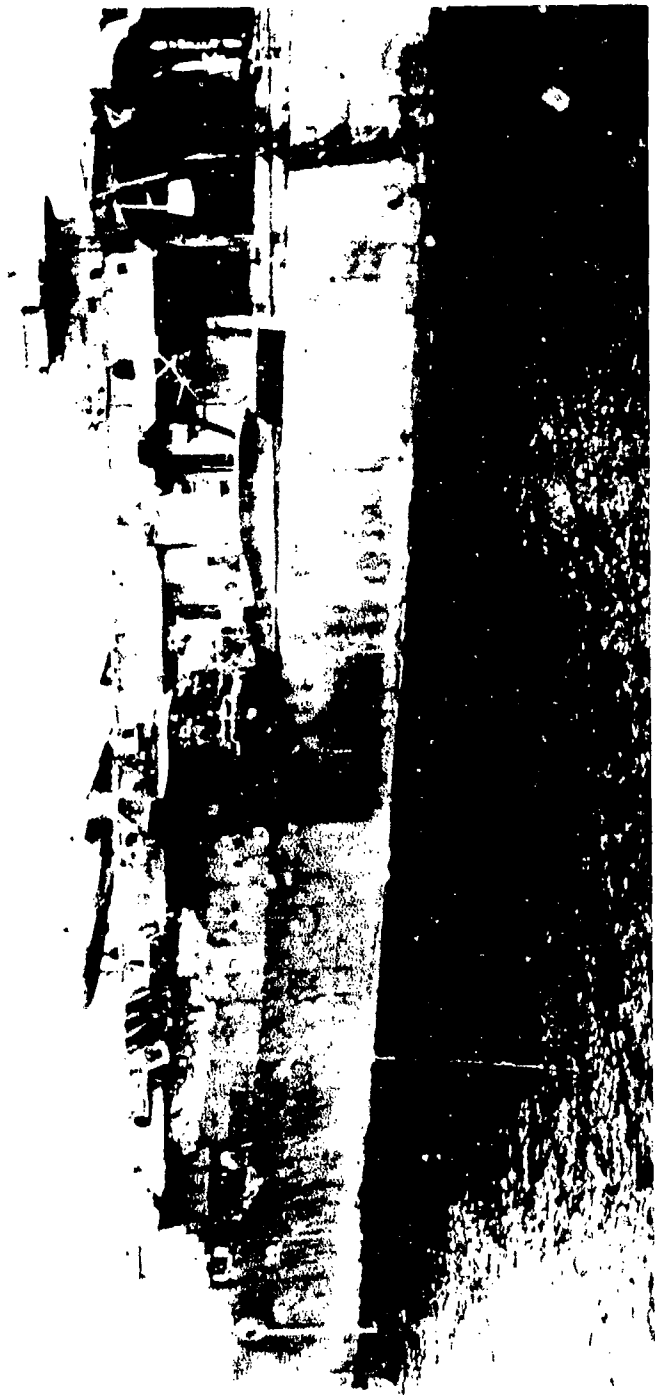
AB-CR-221-353-22. Forward port shell and hangar cover plating viewed from off port beam.
